Dipl.-Ing. Andreas Haacker

CIPP - RENOVATION OF PRESSURE PIPES – STATUS QUO, PERSPECTIVES, QUALITY ISSUES

RSV leaflet 1.1 CIPP

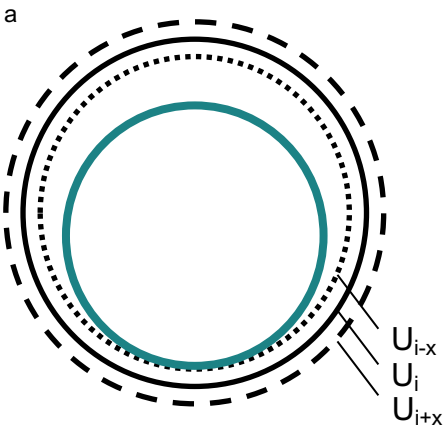
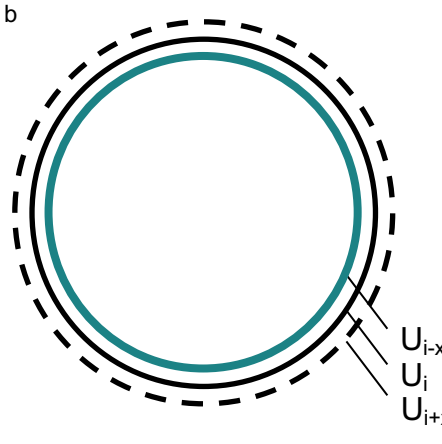
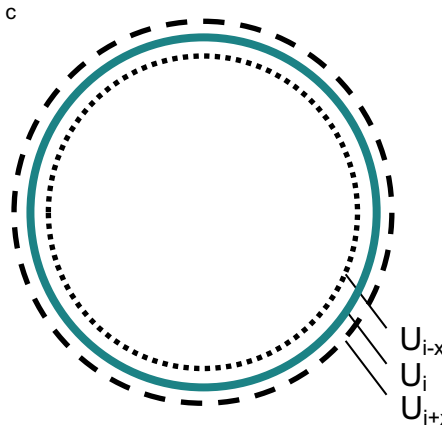
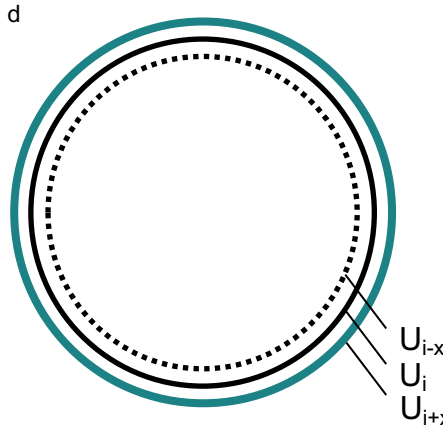
<p>Undersize Corresponds to the production dimensions of the liner hose without expansion</p>	<p>Minimum expansion Minimum necessary expansion from which the carrier/reinforcing material is stretched and compressed and the hose is form-fit to the old pipe</p>	<p>Nominal expansion Expansion of the hose in relation to the internal circumference of the old pipe for ordering the hose</p>	<p>Maximum expansion Maximum permitted expansion of the hose</p>

a: In the condition produced in the factory
(M condition in accordance with EN ISO 11296-1)

b, c, d: when installed (I condition in accordance with EN ISO 11296-1)

- U_{i-x} : Lower tolerance limit of the old pipe, internal circumference
- U_i : Nominal dimension of the old pipe, internal circumference
- - - U_{i+x} : Upper tolerance limit of the old pipe, internal circumference
- liner hose

The elasticity of the liner hose describes its expansion between minimum expansion and maximum expansion. Expansion beyond the maximum expansion is possible but leads to impairments of the laminate quality.

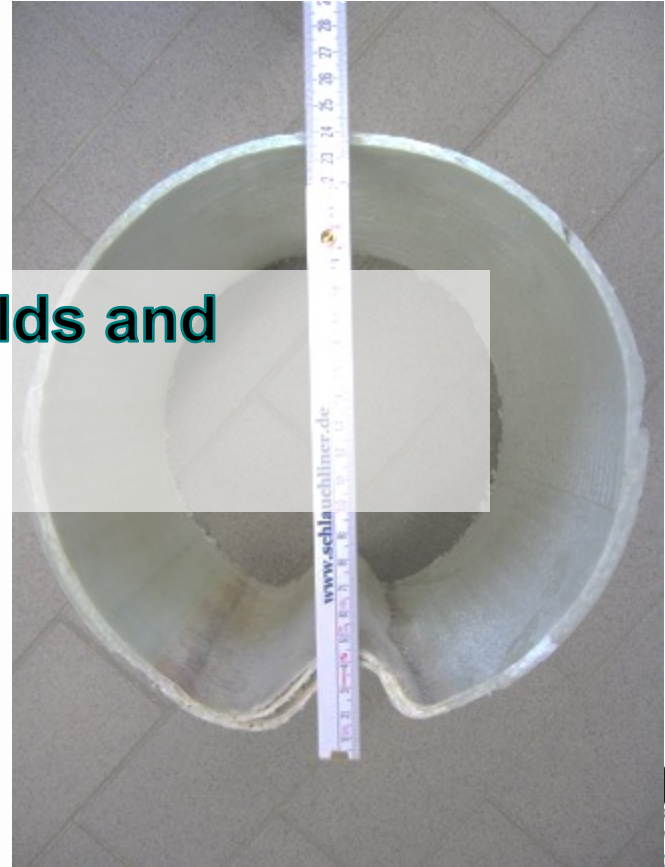
Axial fold / not filled

Fold type	Condition	Possible cause(s)	Evaluation
Axial fold (longitudinal fold) not filled

Restricted access possibilities, cross-section change, pipe offsets, fluctuations of the old pipe diameter, ingress of groundwater (bottom fold), over-long hose, insufficient installation pressure, inadequate hardening	System statically weakened. In case of pure UV-hardened systems can lead to hardening defects (thickness, unfavourable UV angle of incidence). Hardening defects are not expected in heat hardened systems (with the exception of bottom folds).

<p data-bbox="585 736 745 768">Bottom fold</p>

- If wrinkles / folds in CIPP occur it shall be evaluated in relation to the liner system used.
